**CALSPAN ON-SITE AIR BAG DEPLOYMENT INVESTIGATION**

**CALSPAN CASE NO. 93-9**

**VEHICLE #1 - 1990 FORD TAURUS GL (AIR BAG-EQUIPPED)**

**VEHICLE #2 - 1974 CADILLAC COUPE DEVILLE**

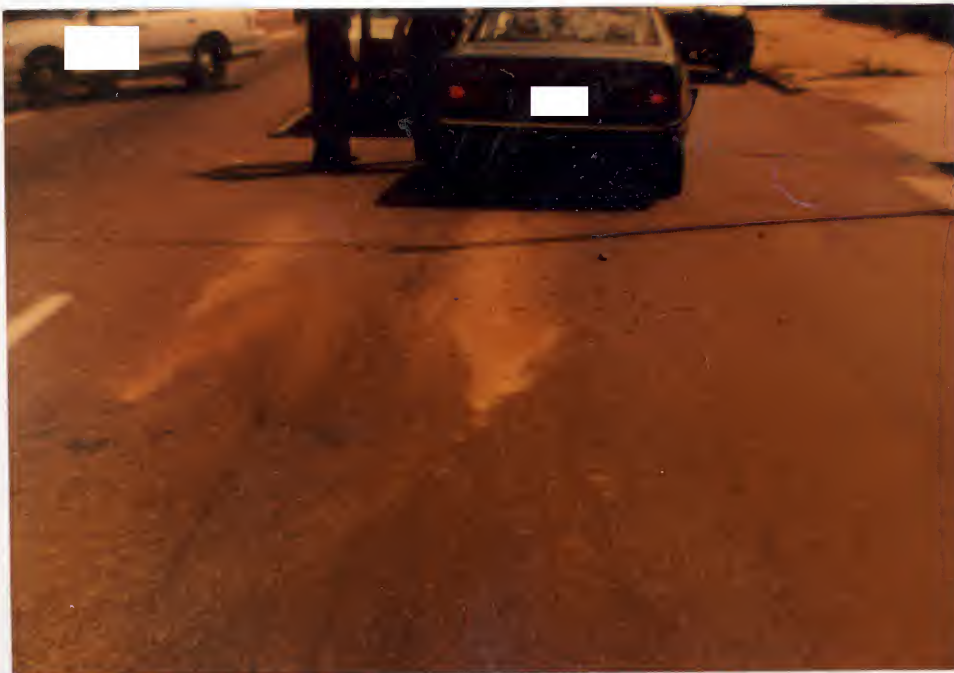
6. Close-up view of dirt debris from Vehicle #2 and radiator fluid spill from Vehicle #1

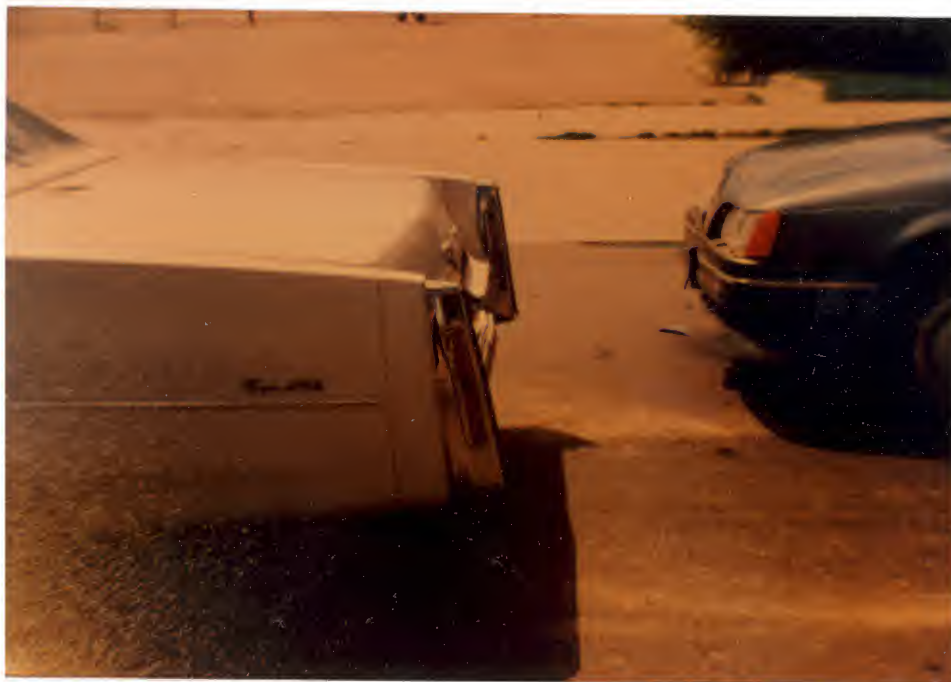
9. Lateral (westerly) view of both vehicles at FRP showing the distance of separation between the rear bumper of Vehicle #2 and the front bumper of Vehicle #1 [1.0 m (3.3')]

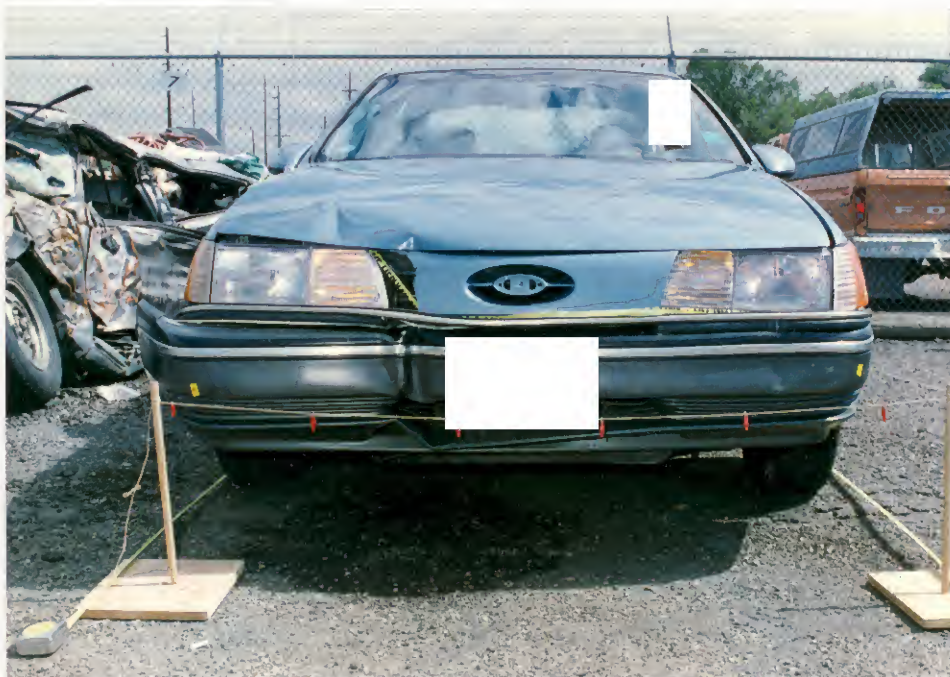
The frontal plane of the 1990 Ford Taurus GL (Vehicle #1) sustained light to moderate damage as the result of two impacts with the rear of the 1974 Cadillac Coupe deVille (Vehicle #2). Vehicle #1 sustained maximum crush of 10.8 cm (4.25") on the bumper face, 23.5 cm (9.25") right of the vehicle's centerline as the result of the first impact. Direct contact damage began at the left front bumper corner and extended 100.3 cm (39.5") to the right, ending at 23.5 cm (9.25") right of the centerline. The impact deformed the entire frontal plane resulting in a combined induced and direct contact damage length of 149.2 cm (58.75"). Crush values at bumper level were:

Components damaged by the frontal impact sequence included the bumper, grille panel, radiator, and hood. The windshield experienced a stress crack which may have been previously initiated by a small stone chip in the glazing and elongated by crash forces. All doors were operational post-crash. The wheelbase dimensions were unchanged from original manufacturers specifications. A damage pattern on the right rear fender and taillight assembly was unrelated to the crash.

13. Frontal view of the 1990 Taurus GL (Vehicle #1)

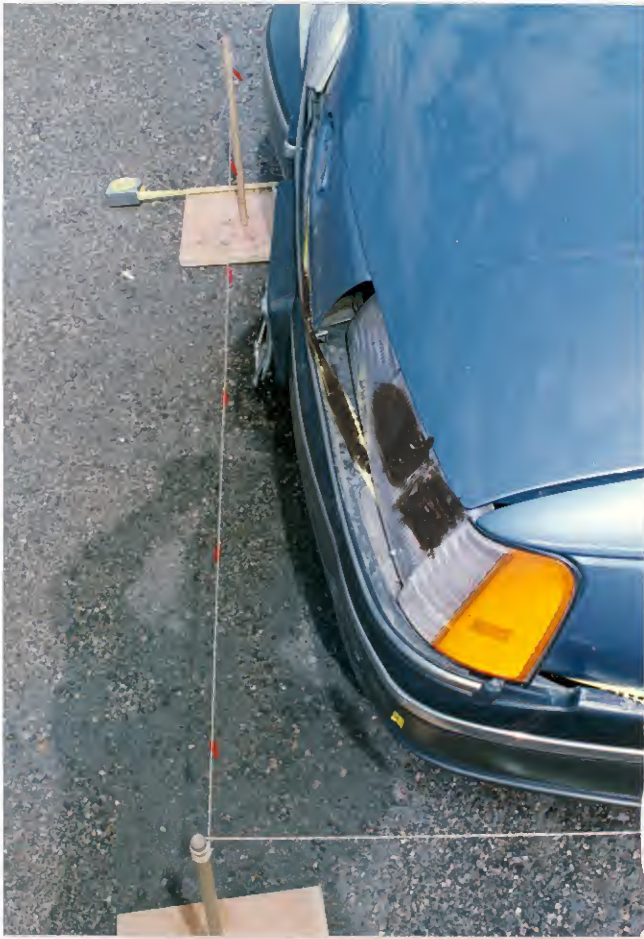
19. Overhead view showing longitudinal bumper displacement

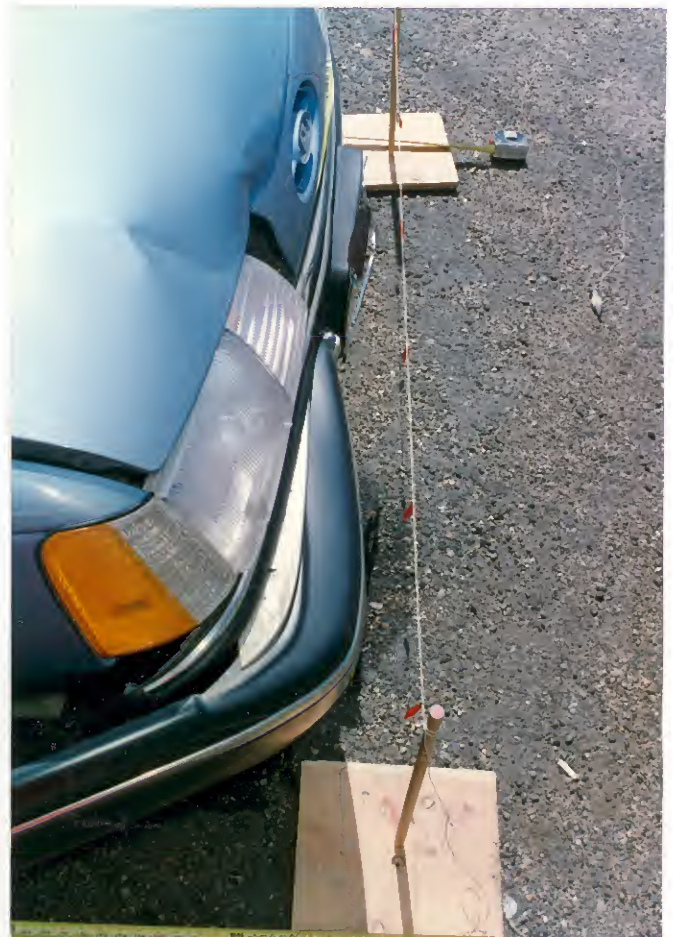
20. Reverse overhead view of bumper displacement

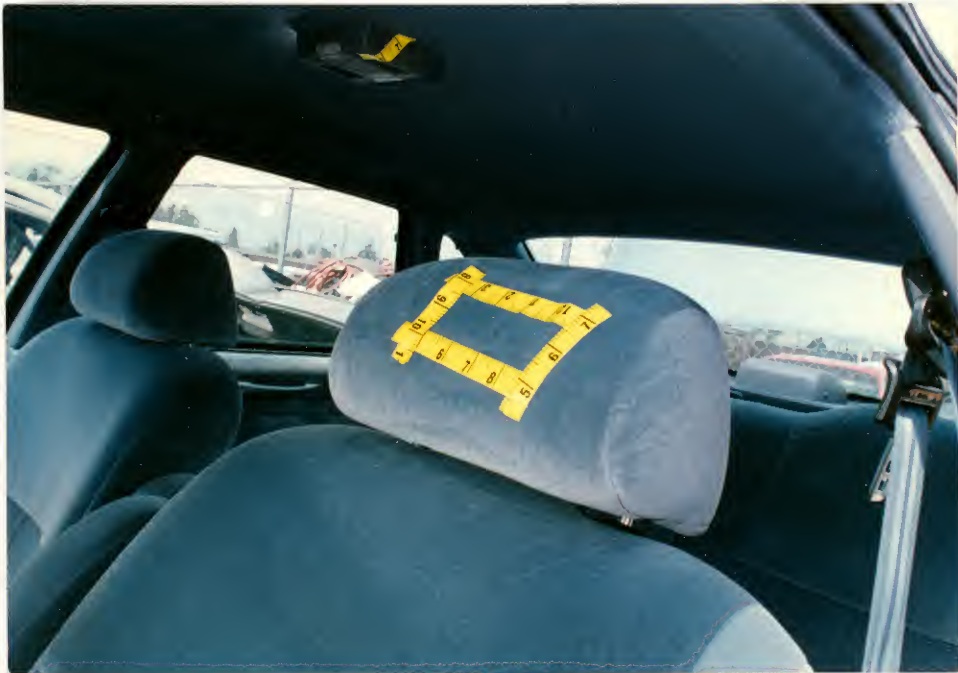
35. Close-up view of contact on the driver side head restraint

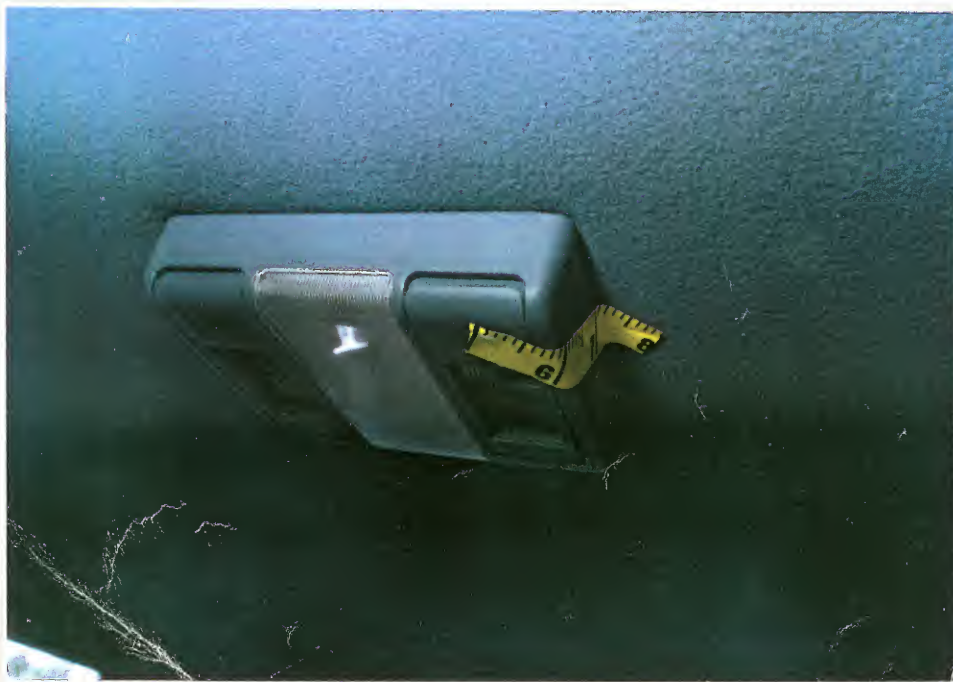
36. Close-up view of contact on the left front corner of the courtesy light bracket

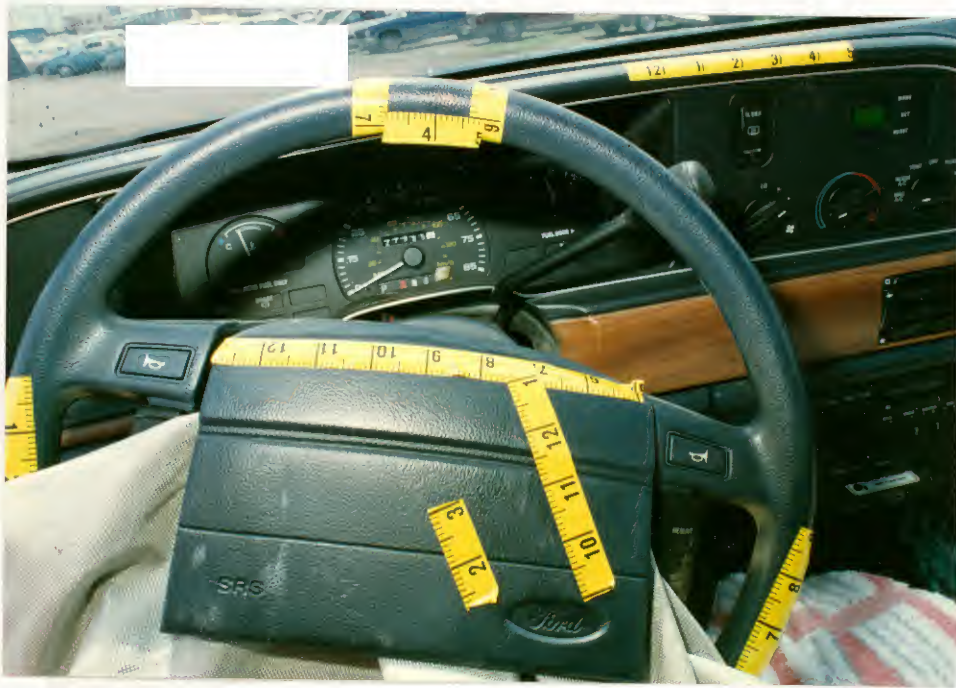
The upper flap of the air bag module cover exhibited abraded surface damage which was attributed to the interaction with the driver's necklace during the air bag deployment sequence. For documentation purposes, the abraded surface damage was divided into three areas. The largest and most visible area began along the bottom edge of the upper flap at 9.5 cm (3.75") right of the left corner and extended 10.8 cm (4.25") diagonally upward to the left, ending 3.2 cm (1.25") from the left side edge of the flap.

There were three skin transfer marks noted on the upper air bag module flap which were attributed to contact with the driver's neck during the air bag deployment sequence. The first was 1.3 cm (0.5") wide and began 1.9 cm (0.75") right of the left flap corner along the horizontal seam edge. This transfer extended vertically 6.4 cm (2.5"). The second transfer was also 1.3 cm (0.5") wide and began 4.8 cm (1.9") right of the left flap corner along the horizontal seam edge. This transfer extended vertically 7.0 cm (2.75"). The third transfer began 8.9 cm (3.5") left of the right corner along the bottom edge of the flap and ended 4.4 cm (1.75") above the seam line. This transfer was 1.3 cm (0.5") wide and less visible than the other skin transfer marks.

39. View of the upper steering wheel rim and upper flap of the air bag module

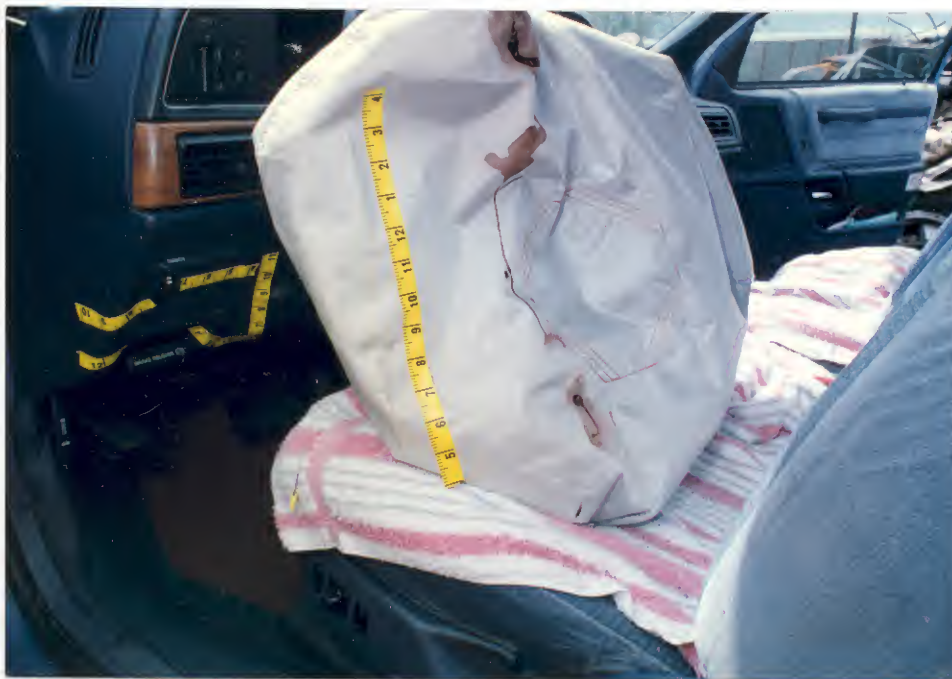
43. Angular view of the air bag and contact along the lower instrument panel

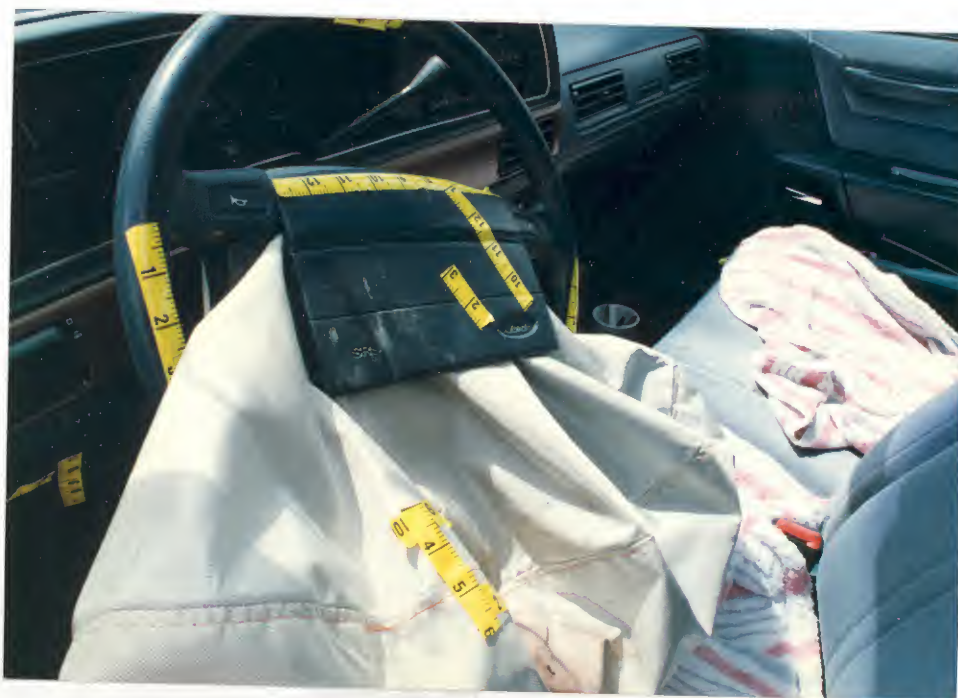
A red lipstick transfer was noted on the instrument panel side of the air bag along the top peripheral seam line left of the center line. Blood deposits from the driver were noted in the upper left and lower left quadrants (Sectors 1 and 3).

44. View of the driver side and instrument panel side of the air bag along the top peripheral seam line

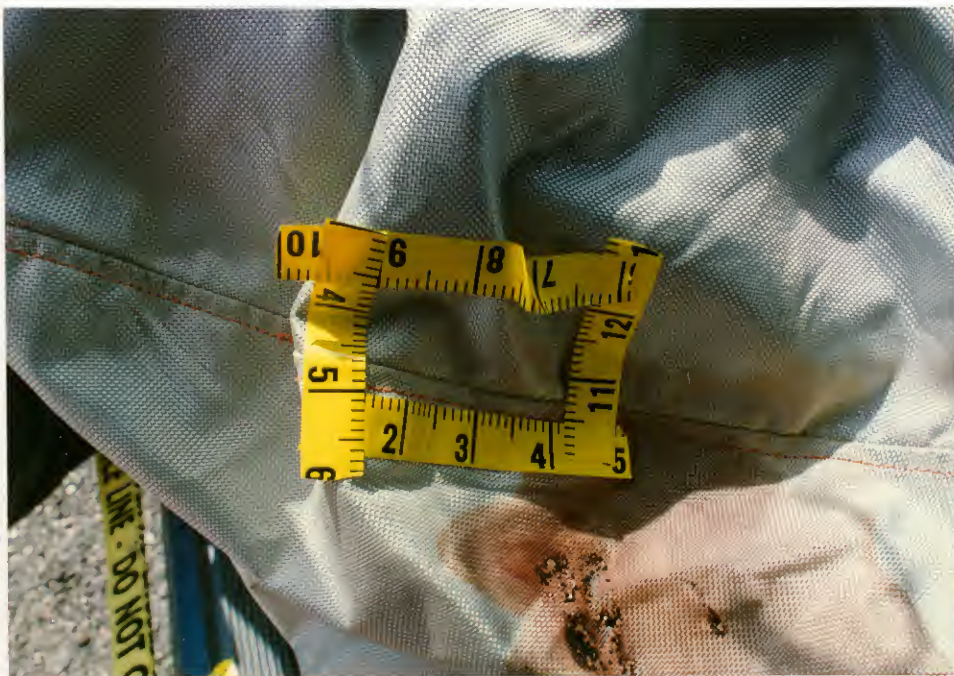
46. Close-up of the red transfer mark on the air bag

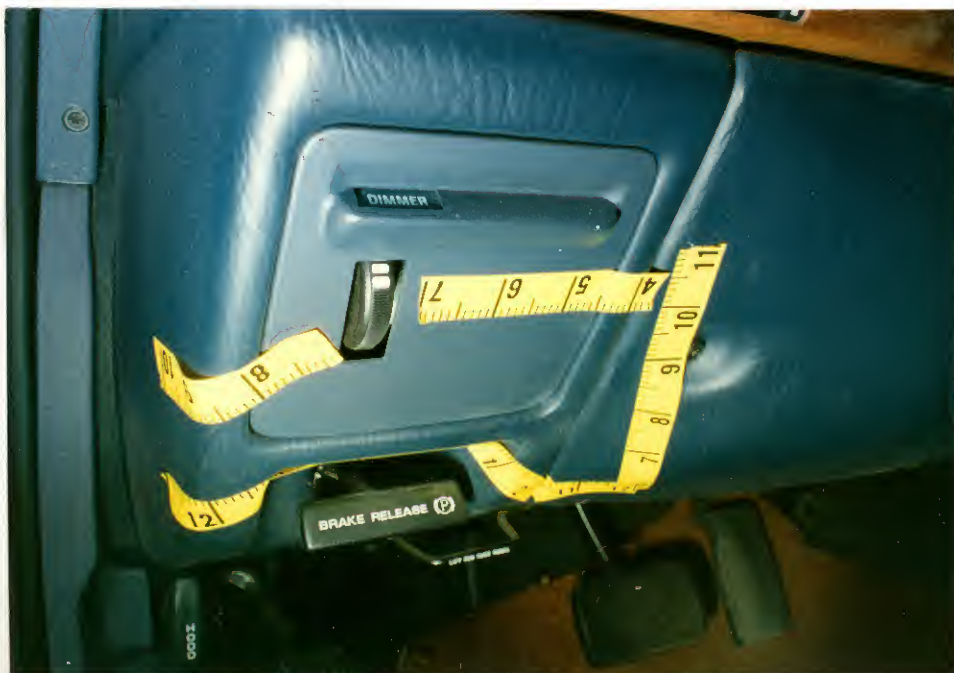
50. Skin and oil transfer on the knee bolster and light switch panel from driver contact

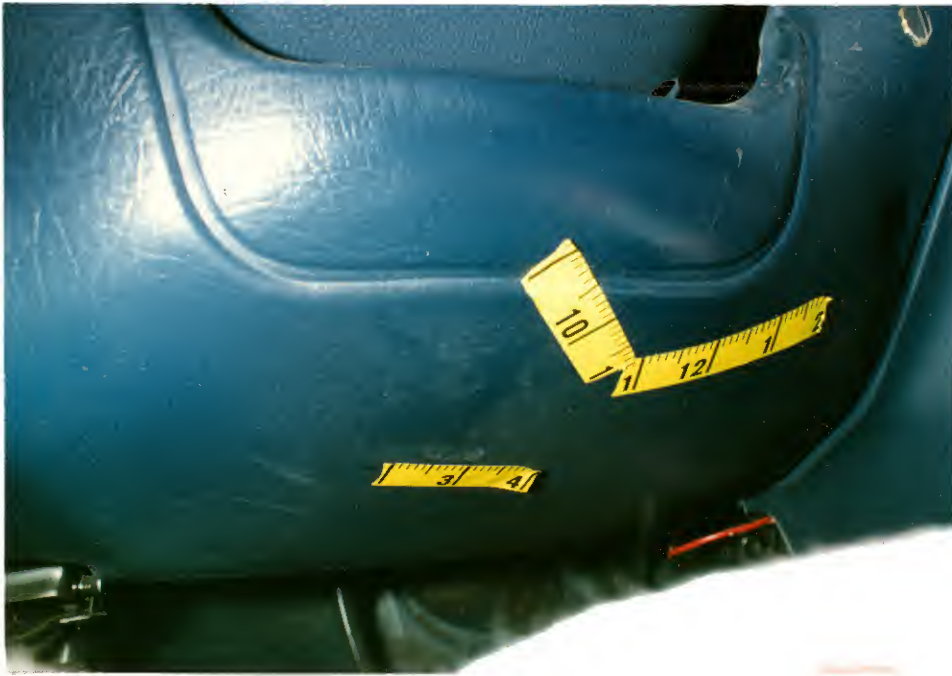
51. Smudges on the knee bolster from driver contact

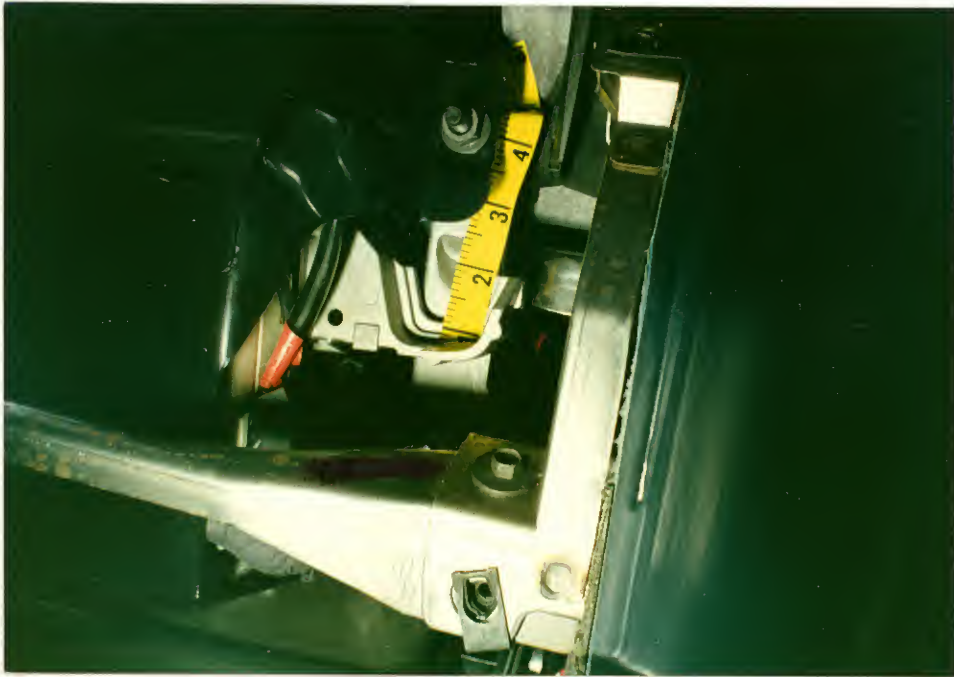
52. View showing the displacement of the left shear capsule

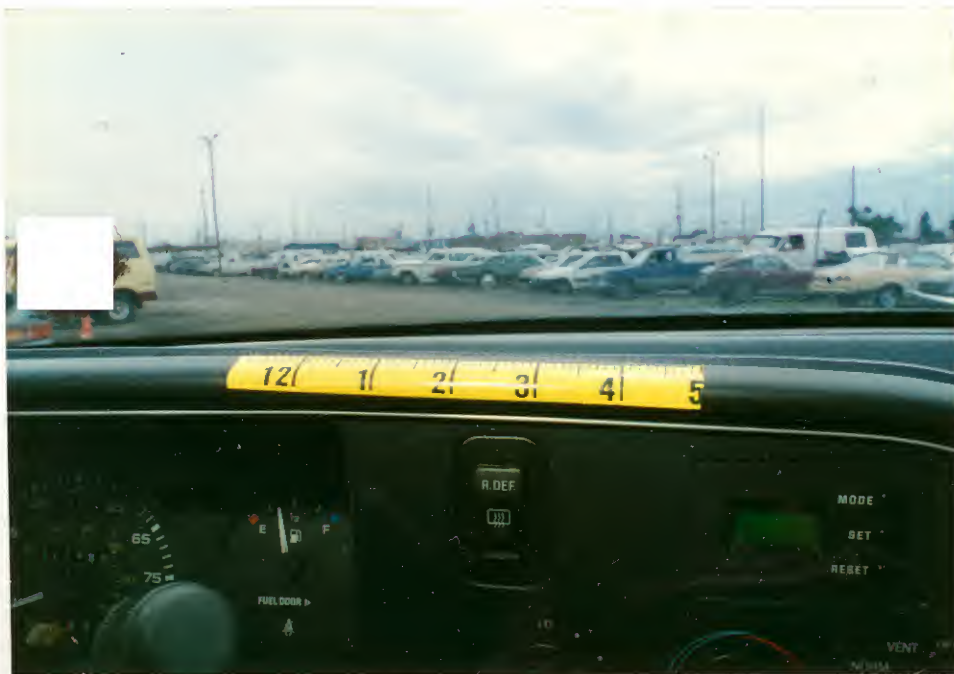
57. Vertical view of the center instrument panel highlighting driver contact along the upper edge of the instrument panel

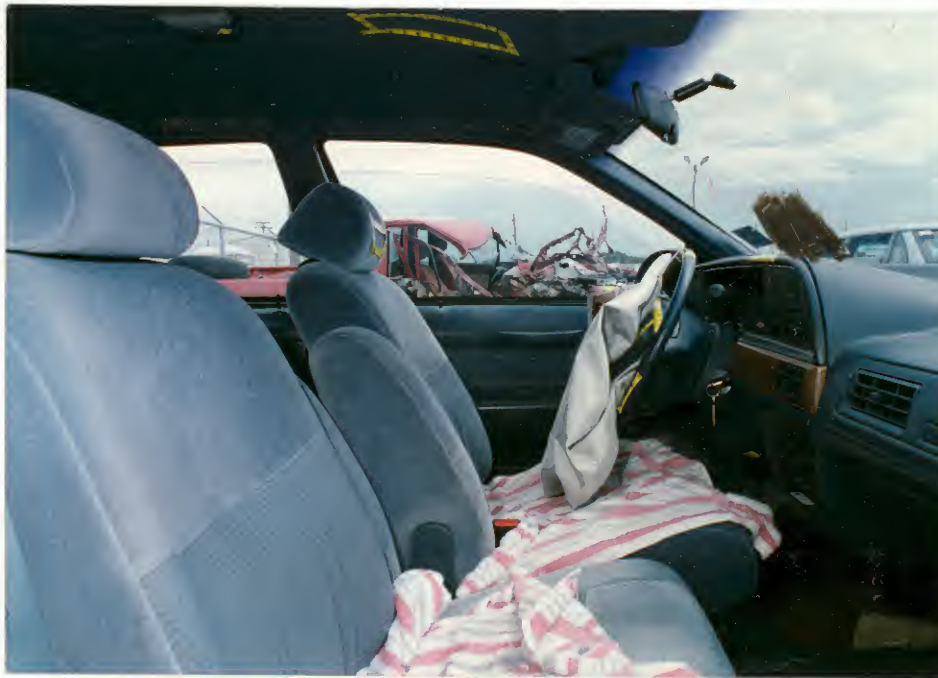
60. Angular view of the instrument panel from the right front passenger side showing driver contact points and relative positions of the front seats

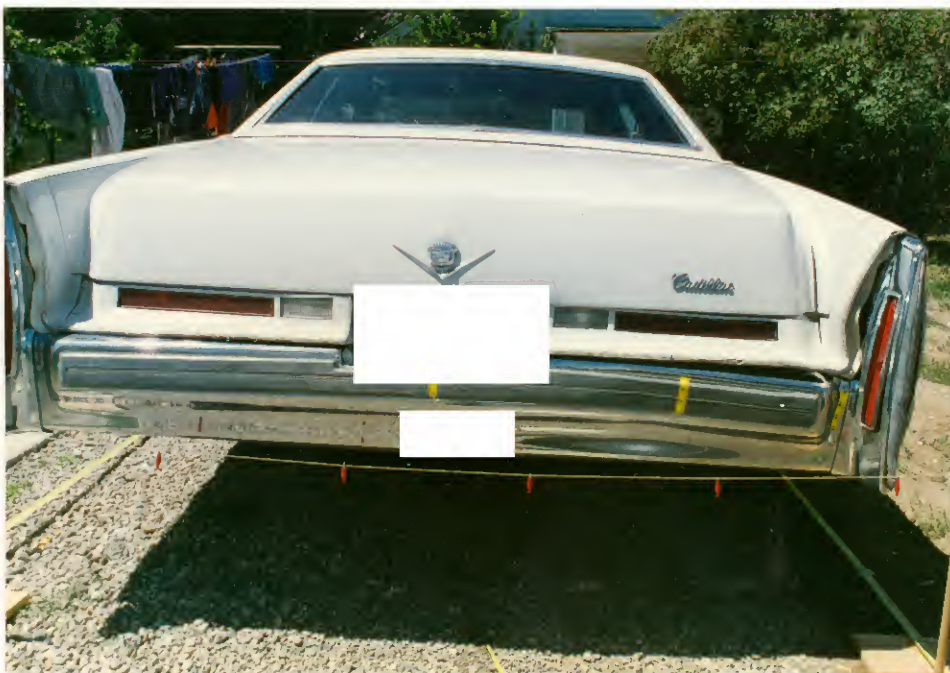
69. Overhead view from the left side of the rear plane illustrating bumper displacement

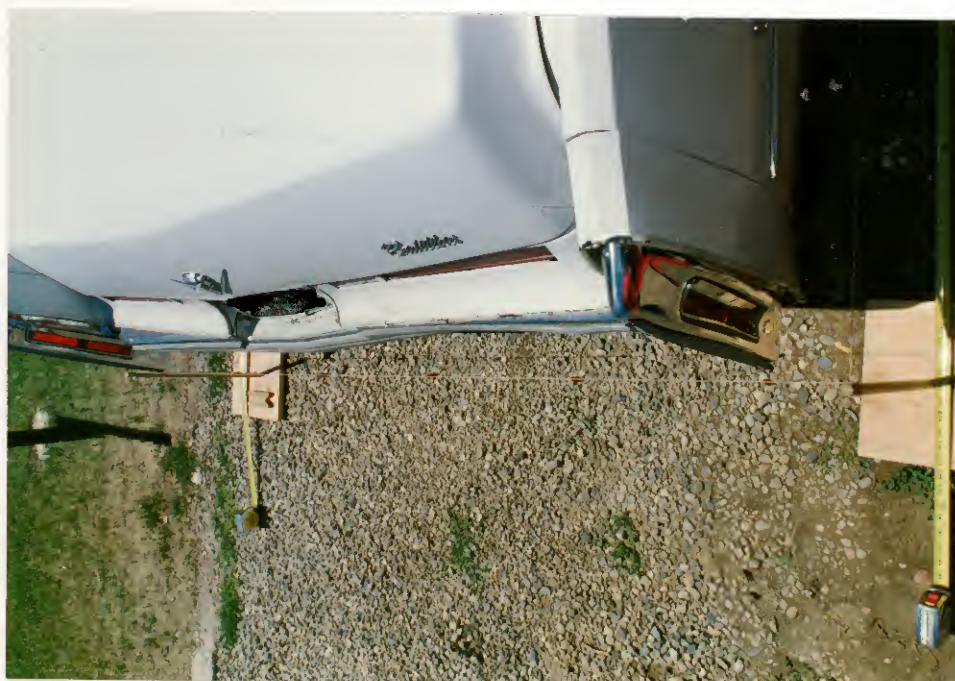
71. Close-up view of the right bumper area showing contact evidence along the rub strip produced by the license plate of Vehicle #1 (highlighted by the yellow calibrated tape)

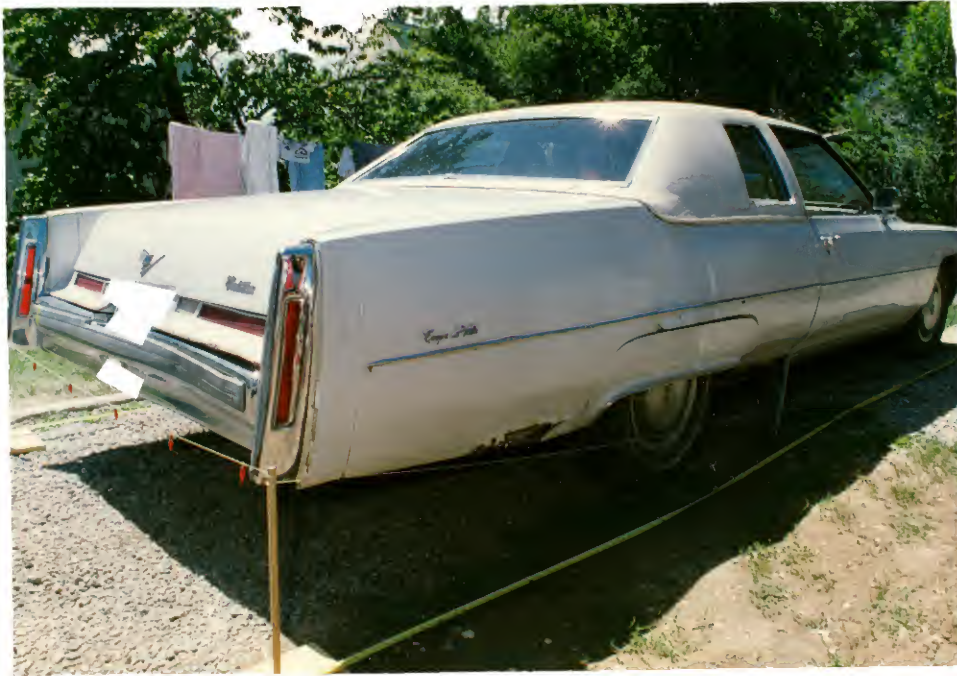
72. Overhead view from the right side of the rear plane showing bumper displacement
